VVPSS Rupture Disk Testing BS&B Phase 2

ITER 32" Rupture Disk Follow-Up Testing

ITER International Fusion Energy Organization

This report details the observations and conclusions from follow up full scale performance testing conducted at BS&B's PremcoLA facility in Monterey, Mexico between 26th February and 5th March 2015. The focus of this testing was rupture disk and safety head fragmentation control and enhancements were tested. The earlier work was completed under BS&B references SO 12311007 to procedure EI-SF-0011.

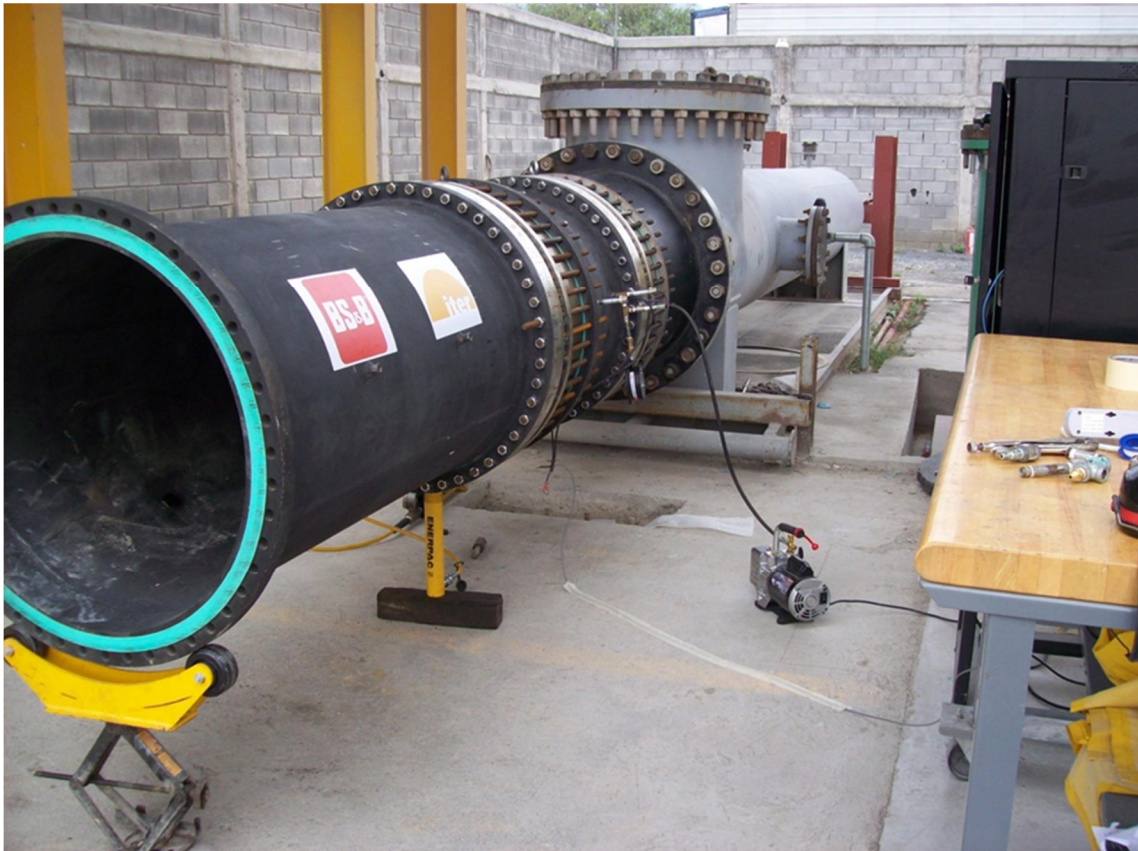
P2-1: Test Assembly (Double-Disk)

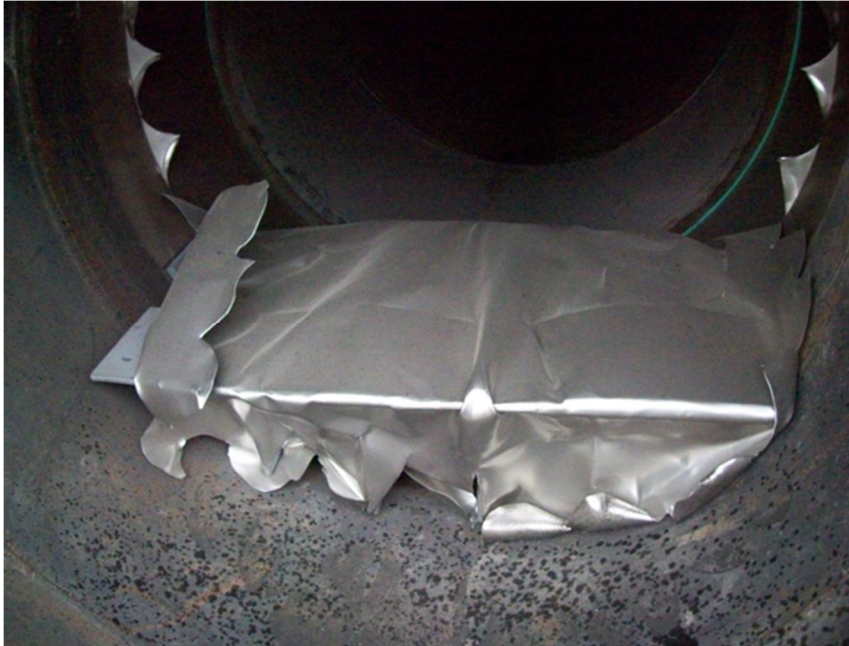
P2-2: Upstream high pressure disk (JRS).

The upstream disk (JRS) opened fully, exhibited no fragmentation and it latched to the bottom of the safety head hinge.

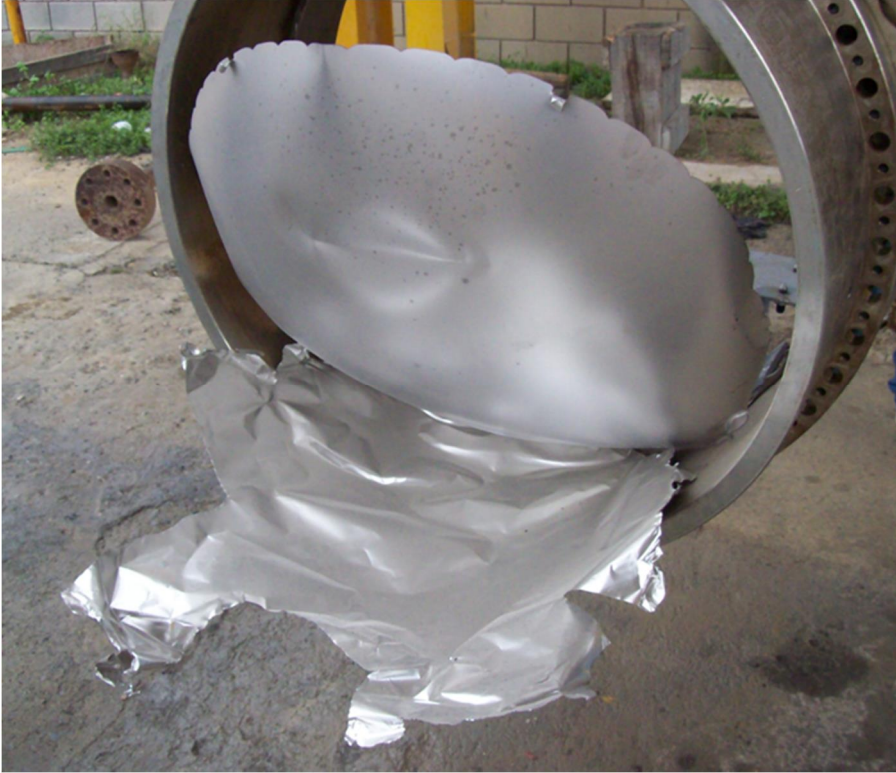
P2-4: Downstream disk (VSP-SH) with partial fragmentation of seal dome. Disk support is shown in reversed direction, as removed. Bend line is from hitting the first disk safety head hinge during reversal flow.

The opening of the VSP-SH was partial, as it did not bend around the new safety head hinge. This was anticipated from 8" prototype test results. A back-up plan was implemented and ready for the arrival of Michael Meekins.

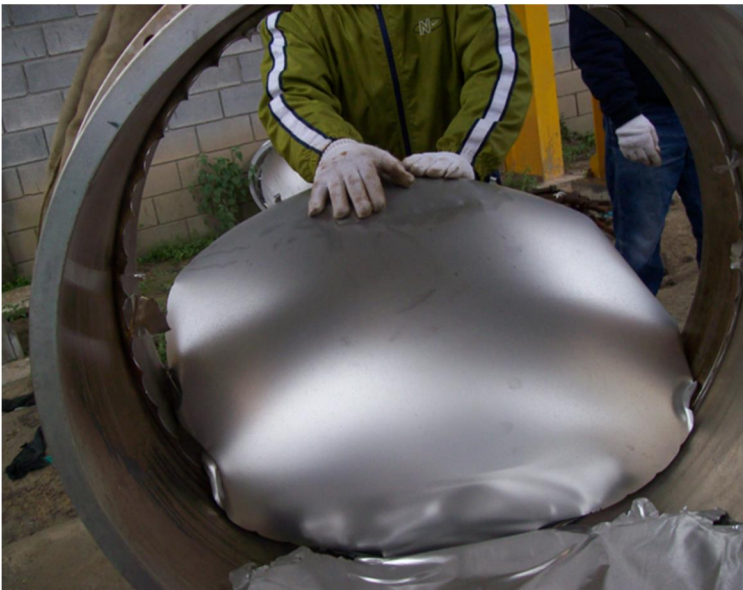
P2-5: Downstream disk (VSP-SH) is being held down in outflow direction, illustrating the minimal bending around the safety head hinge, and the reduced opening.

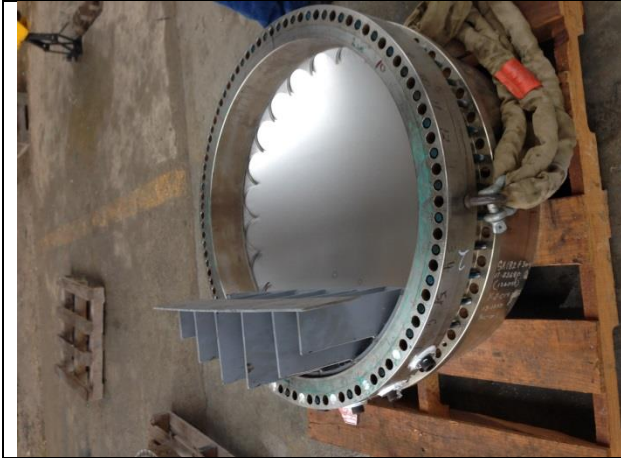
P3-1: Upstream Disk (JRS)

The upstream high pressure disk (JRS) opened fully, exhibited no fragmentation, and it latched to the bottom of the safety head hinge.

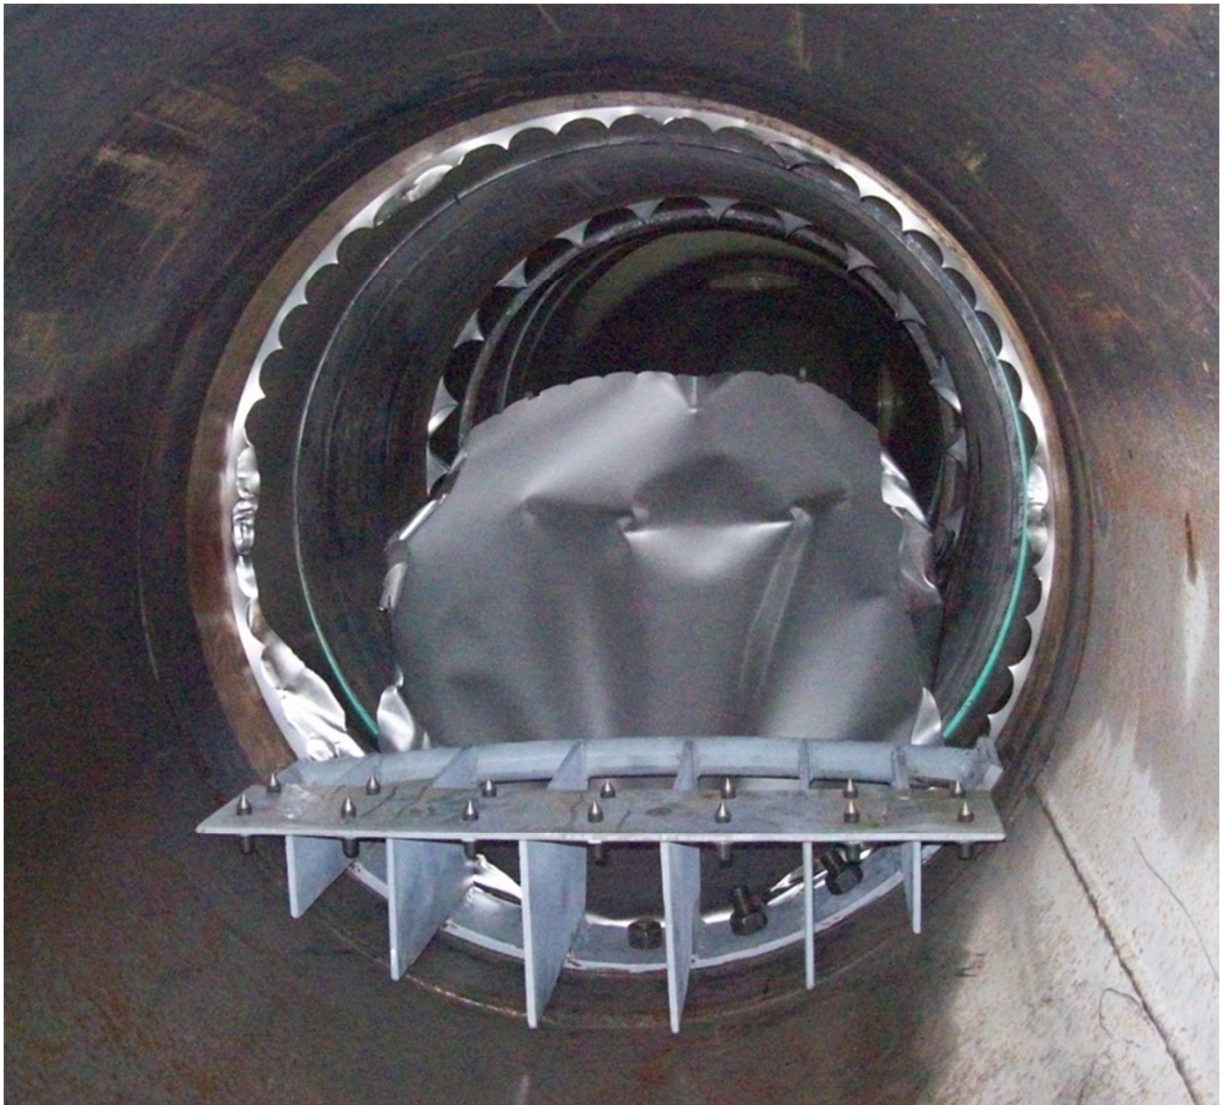
P3-3: View into piping after opening, before disassembly.

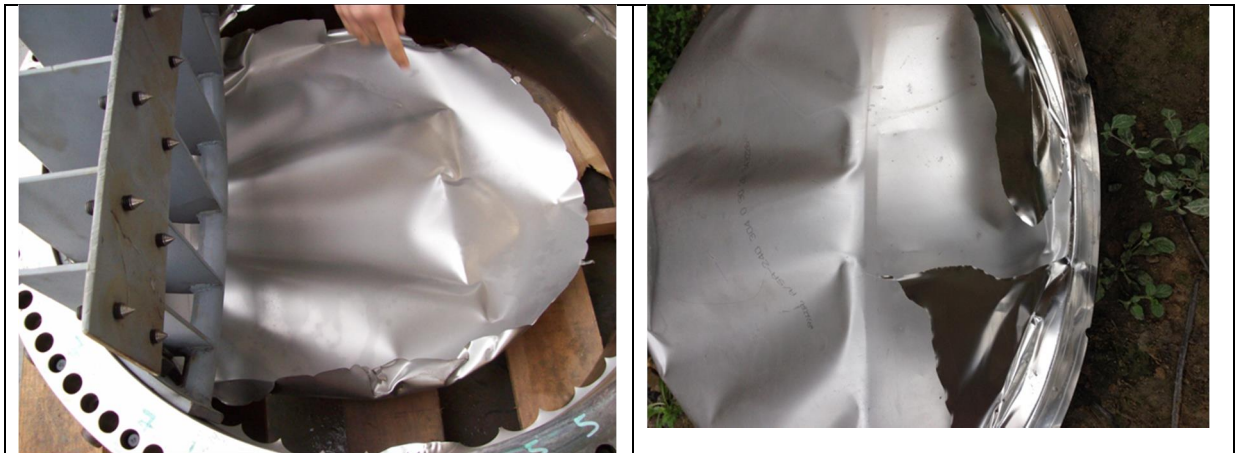
P3-6: Downstream Disk (VSP-SH) support.

P3-7: Downstream VSP-SH seal fragment.

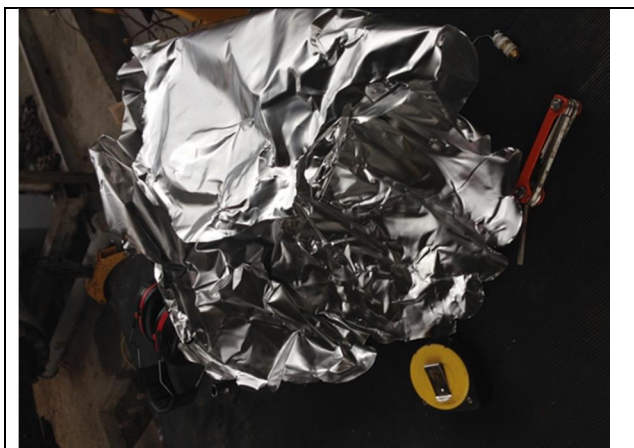
P3-8: Downstream Disk (VSP-SH) seal; fragmented.

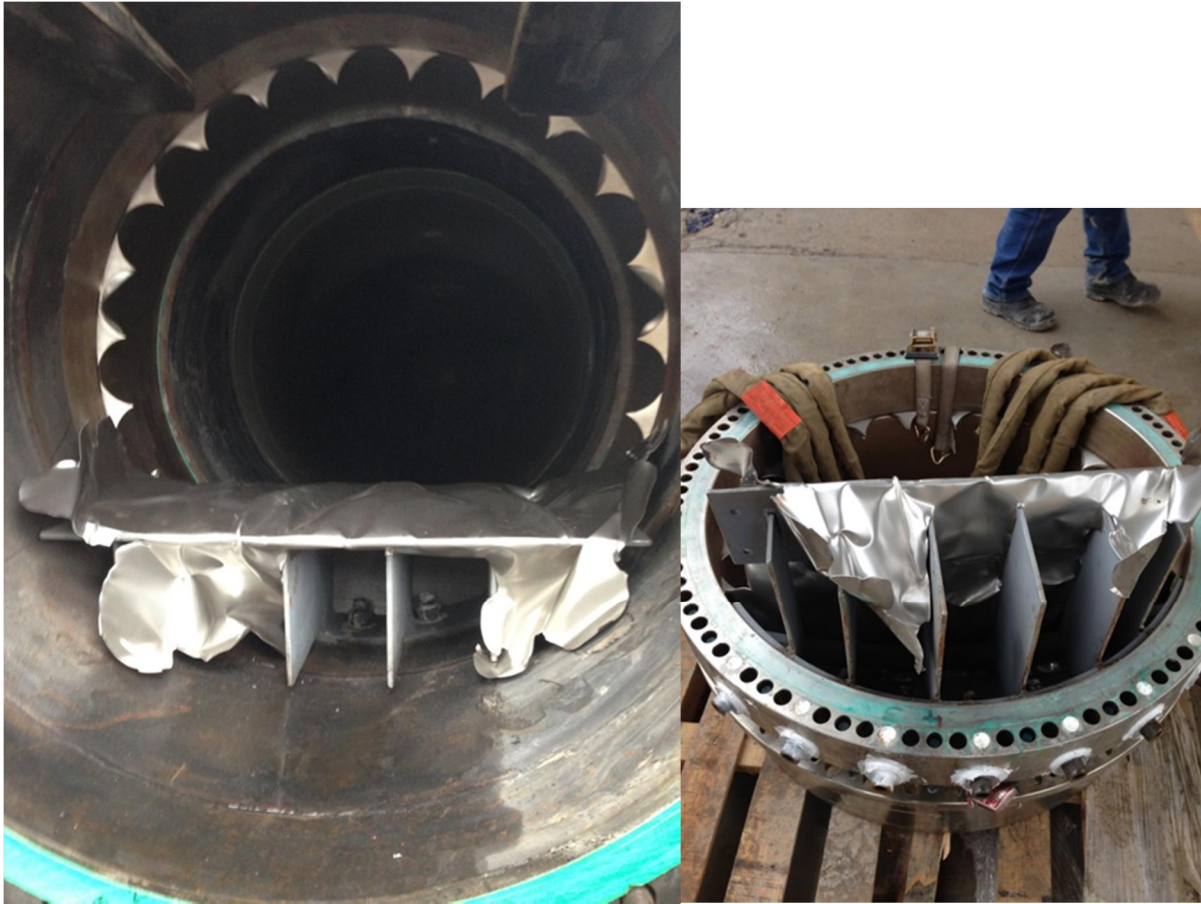
P3-9 & P3-10: Upstream JRS Disk

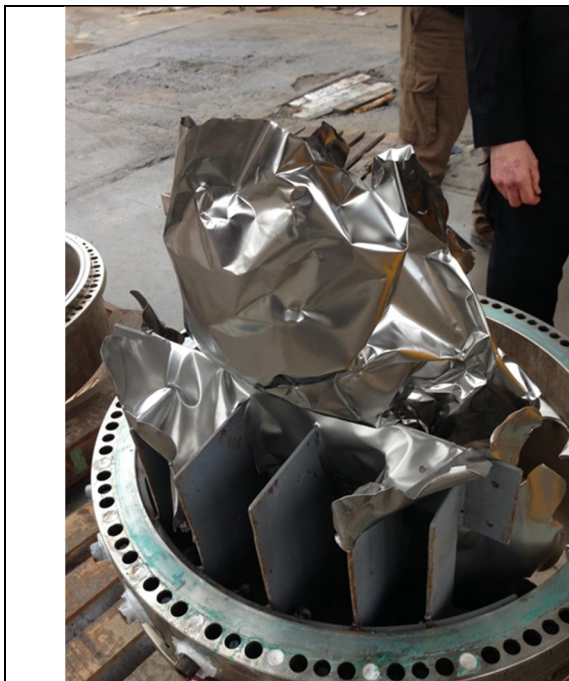
P3-11: The fragmented VSP-SH seal was placed on the JRS disk to illustrate where it hit during the first reverse flow.

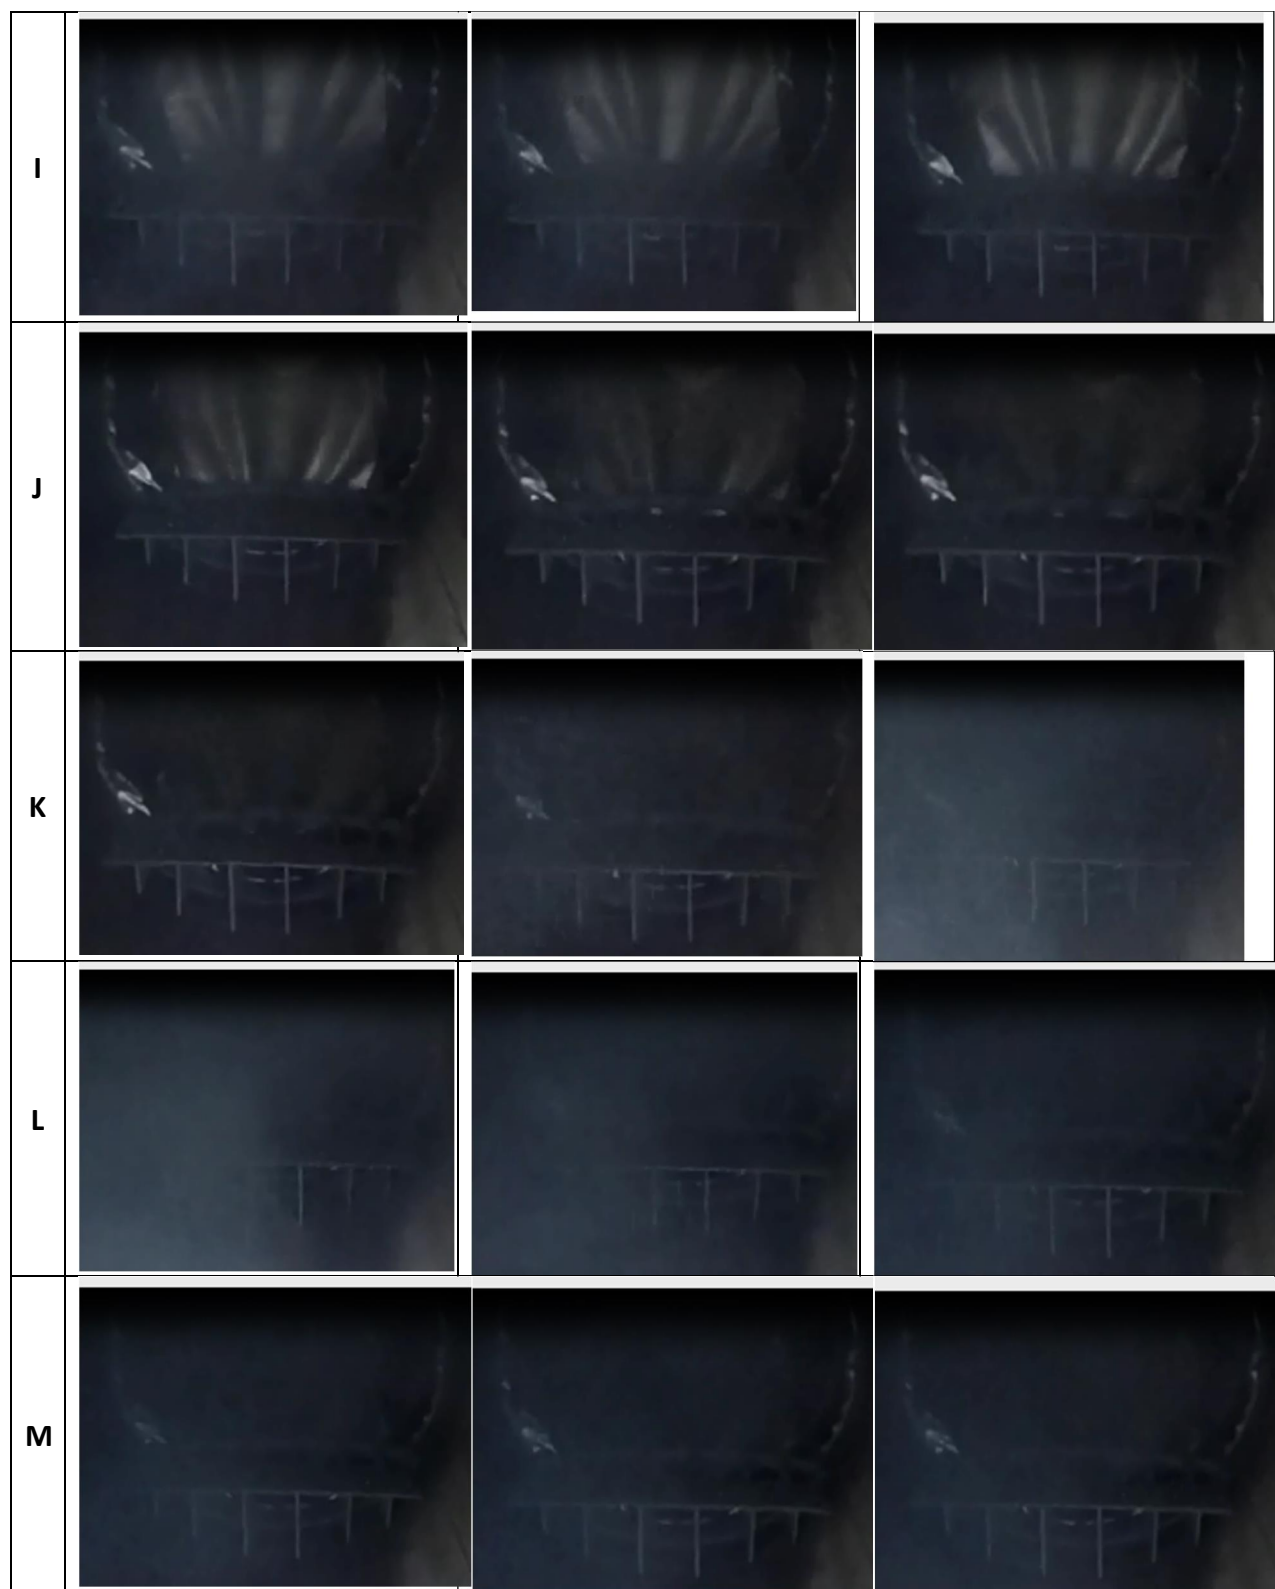
P3-12: Pictures A1 to X2 below from GoPro video from test#3

The GoPro video frame rate was 240 frames per second. Below are the frames of interest. Each white-out is the exhaust of vessel air (water mist condensation). The frames show the buckling of the VSP-SH disk, followed by burst, and then white-out, then reverse flow back into the tank, then subsequent cycles of flow and reverse flow. The reverse flow lifted the VSP-SH off the hinge and bent it backwards toward the tank, slamming it on the safety head hinge of the upstream disk.

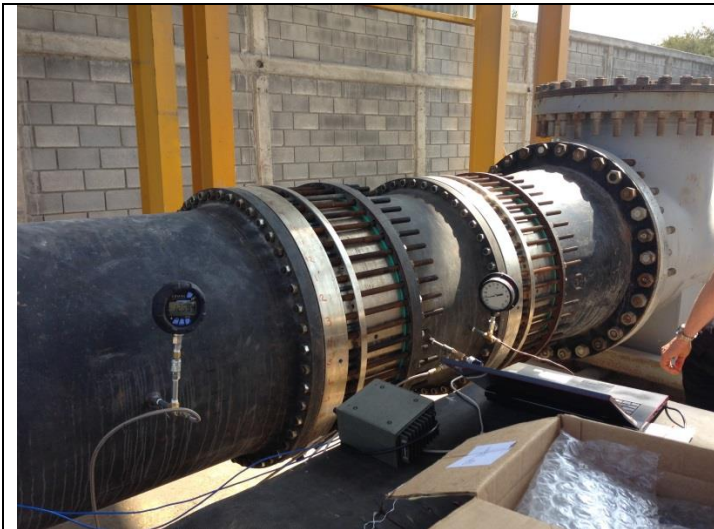
P4-1: Test Assembly: Vacuum gauge on both spools

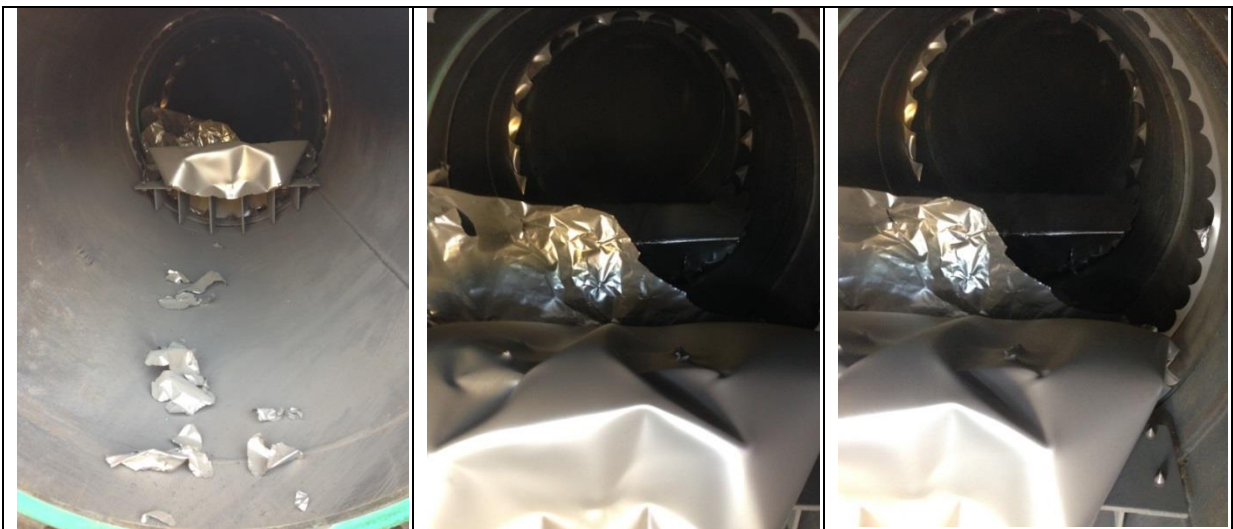
P4-4, P4-5 & P4-6: View after blind flange is removed.

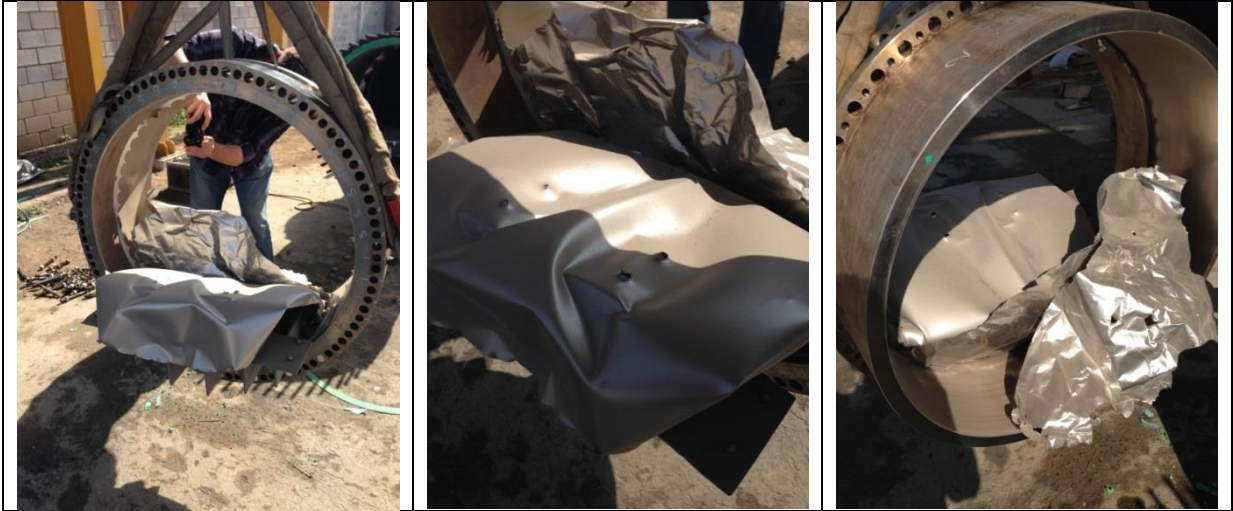
P4-7, P4-8 & P4-9: downstream low pressure VSP-SH - penetration holes and fragmentation.

The downstream low pressure disk (VSP-SH) seal did tear off and fragment into smaller pieces. There is no way to determine at what point the seal tore off. The safety head support and seal domes both had penetration marks from the pins. They both hit the safety

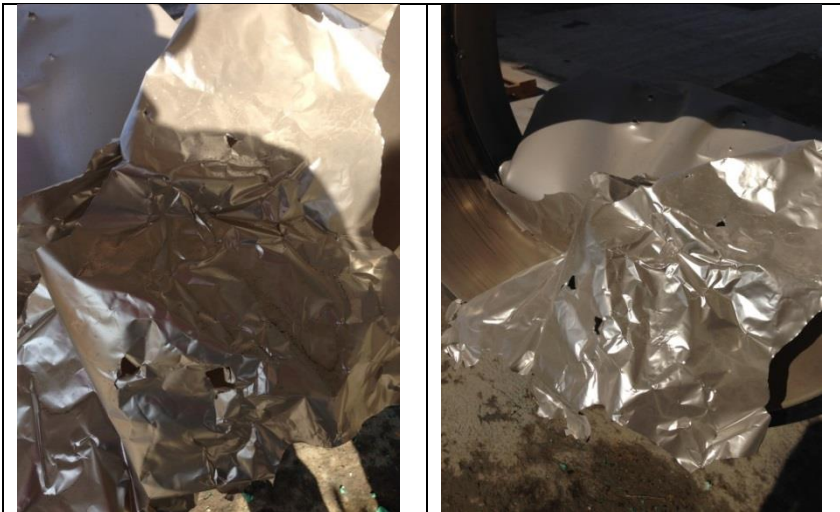
P4-10 & P4-11: VSP-SH seal dome close up.

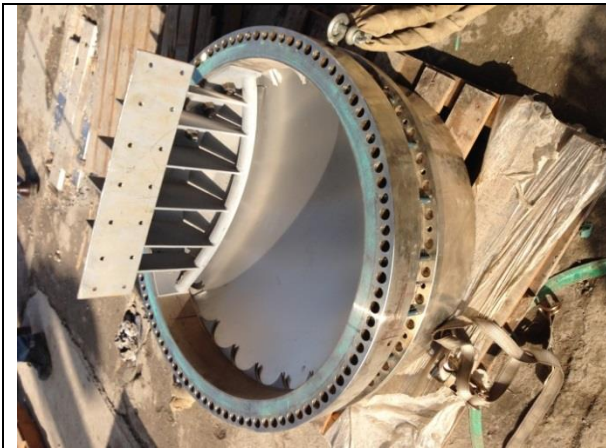
P5-1: Upstream disk (JRS)

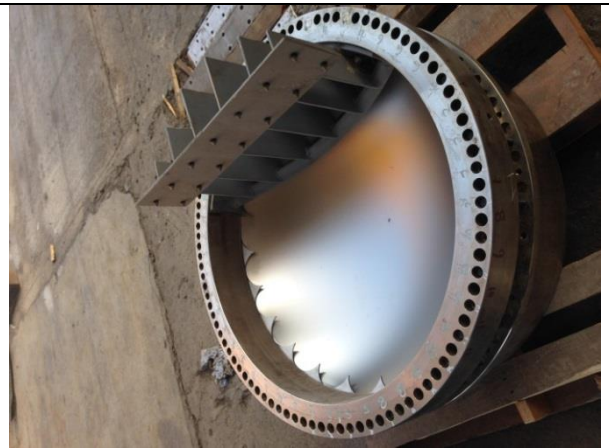
P5-2: Downstream disk (LP JRS)

The downstream disk (low pressure LP JRS prototype) mostly fragmented and blew out. It appears the tearing initiated from the two half-teeth of the tooth ring, nearest to the safety head hinge. It may be that removing these teeth will prevent fragmentation.

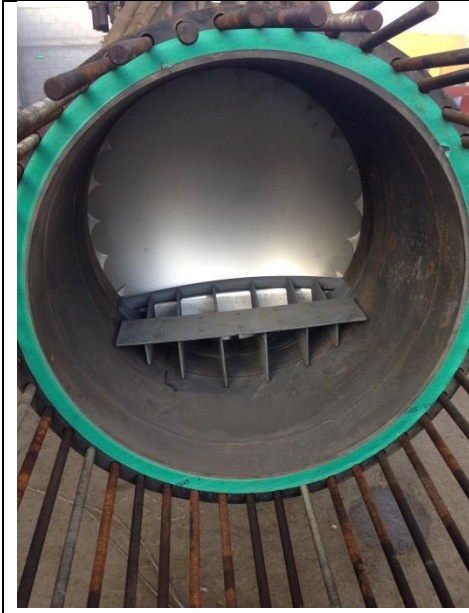
P5-3: Upstream disk (JRS)

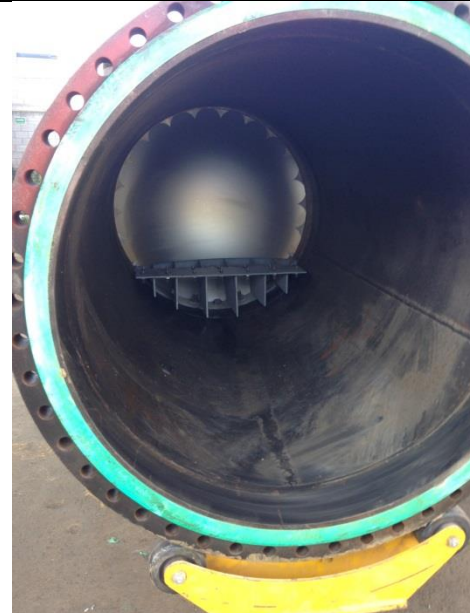
P5-4: Downstream disk (LP JRS)

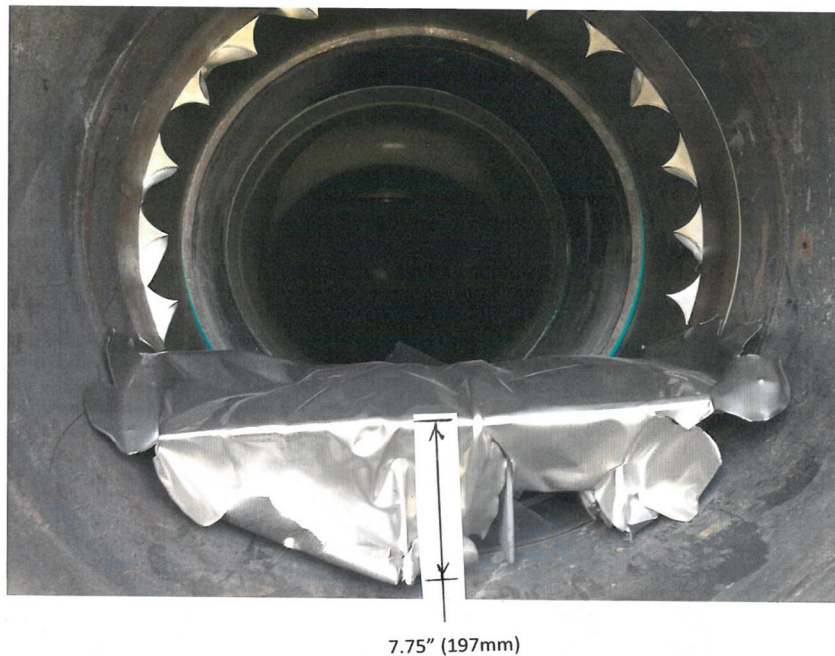
P5-7: upstream disk (JRS) measurements

Shown above is the upstream disk, after opening. The 7.75" hinge height of flow obstruction, includes an approximation of the average disk petal thickness above the safety

head hinge. The spool inside diameter is 31.25". The cutting tooth ring has 18 teeth exposed (the 2 half-teeth are covered by the disk petal).

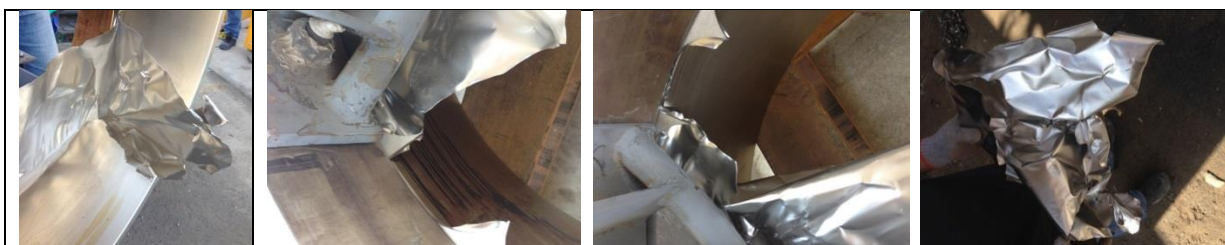
P5-12: Downstream disk (LP JRS) fragments and tear along tooth

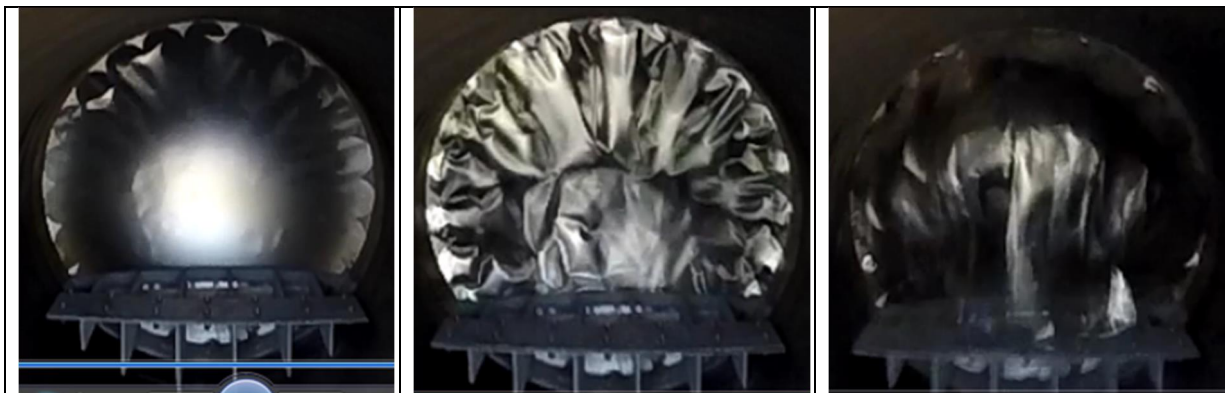
Below are pictures from GoPro High Speed Video. Frame rate is 240 frames per second:

P5-13, P5-14 and P5-15: Downstream disk (LP JRS) view - initial opening

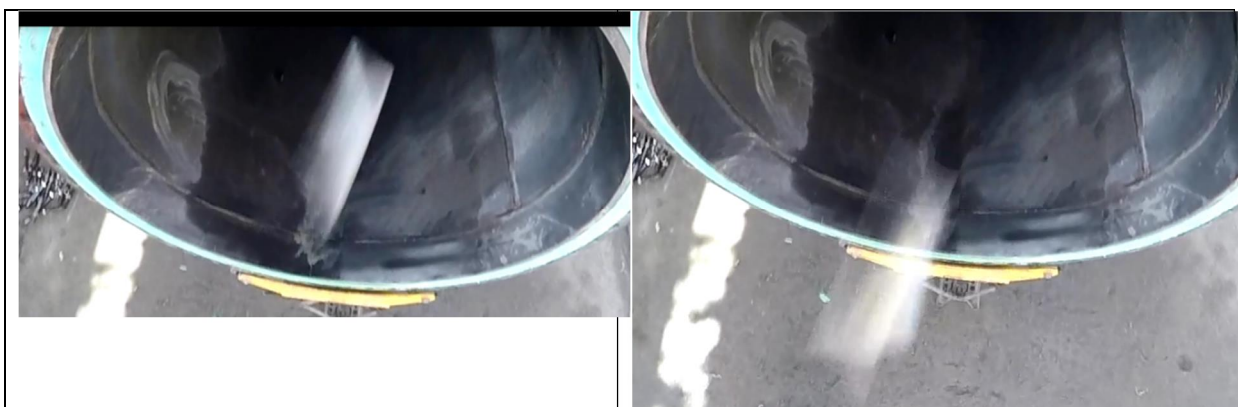
P5-18: Downstream disk (LP JRS) view – camera swivelled due to blow – fragment

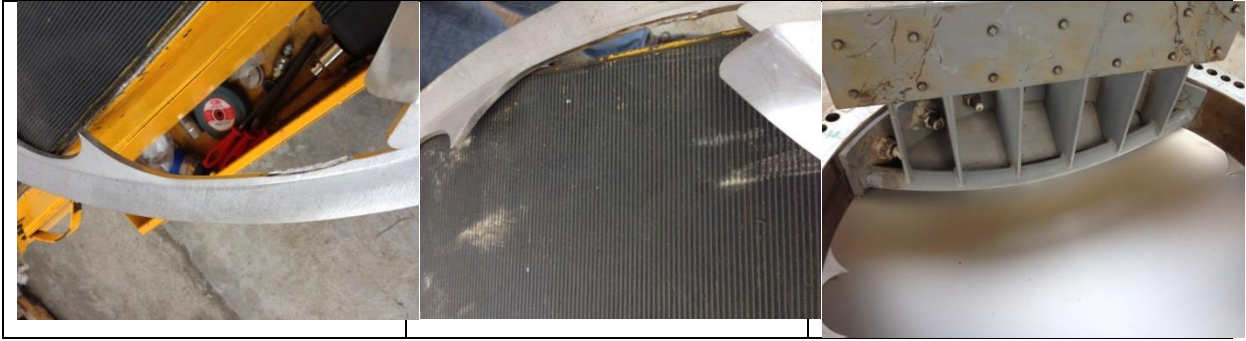
P6-2: Two half-teeth cut off on second disk low pressure JRS LP.

This test is the same as #5 except the second disk tooth ring has the two half-teeth cut off. Also two transducers were installed, one in each spool.
